## CORRECTIVE ACTION STABILIZATION QUESTIONNAIRE

Facility Name: Ball CorporationEPA Identification No.: IND 000 810 713Location (City, State): Muncie, IndianaFacility Priority Rank: ModerateRECEIVED  
WASTE RECORD CENTER

# **TES 9**

Resource Applications, Inc. (RAI) performed a preliminary assessment and visual site inspection (PA/VSI) to identify and assess the existence and likelihood of releases from solid waste management units (SWMU) and other areas of concern (AOC) at the Ball Corp. (Ball) facility in Muncie, Indiana. This summary highlights the results of the PA/VSI and the potential for releases of hazardous wastes or hazardous constituents from SWMUs and AOCs identified. In addition, a completed U.S. Environmental Protection Agency (EPA) Preliminary Assessment Form (EPA Form 2070-12) is included in Attachment A to assist in prioritization of RCRA facilities for corrective action.

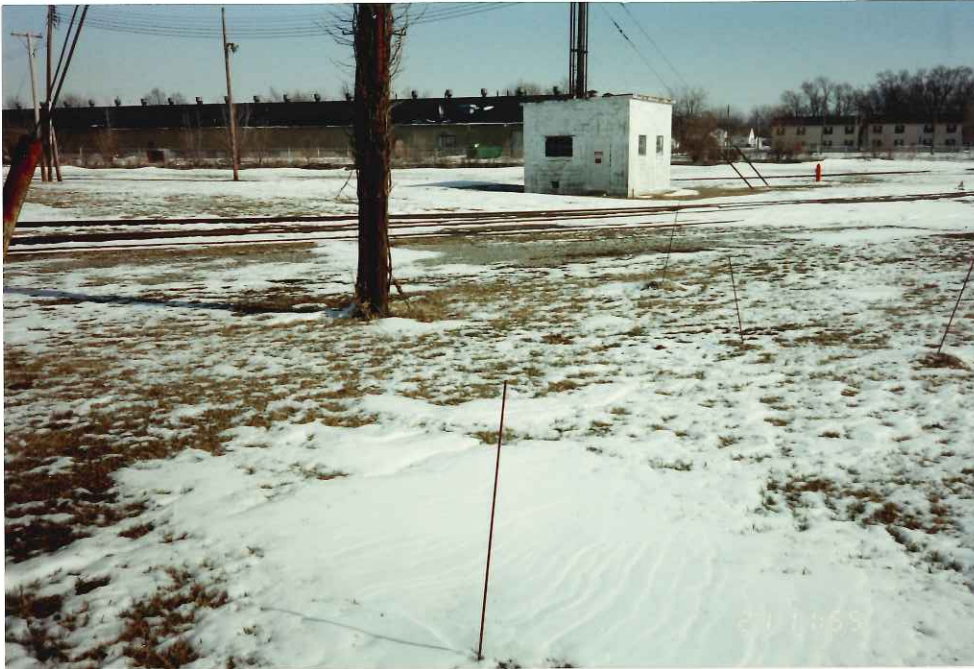
Location: SWMU 1  
 Date: January 21, 1992.

**Unit Description:** Building 56 was located on the southern portion of facility property. The unit was used to manage hazardous wastes for greater than 90 days. The 25-foot by 25-foot steel framed unit had brick curtain walls and a concrete floor (see Photograph No. 1).

Photograph No.1  
 Orientation: South  
 Description: This is the former location of Building 56.

Recommendations: Additional soil testing should be conducted in order to define and characterize the contaminants.

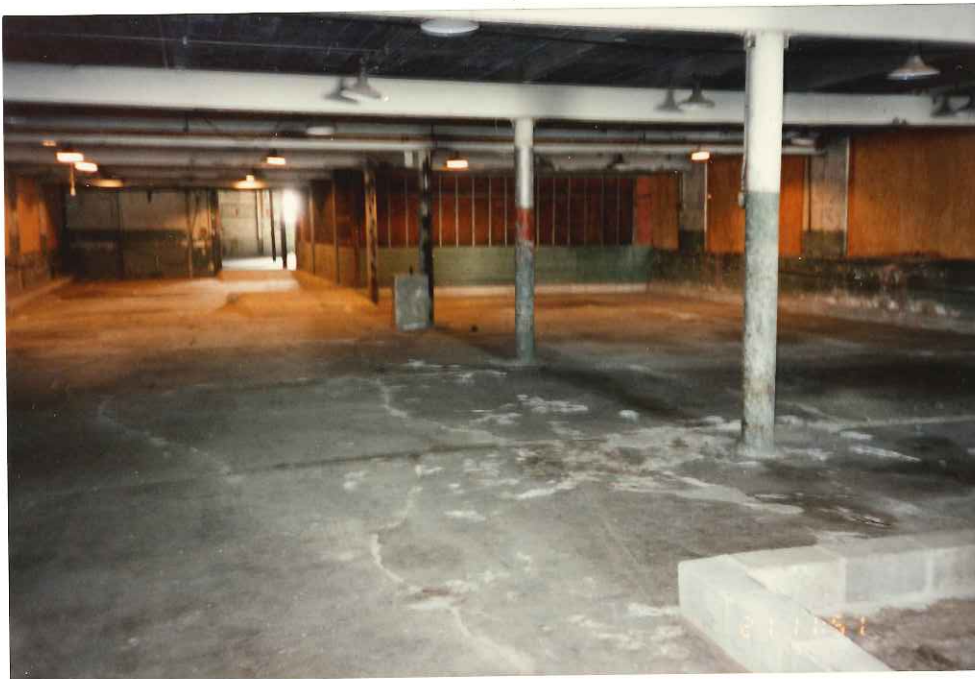
Location: SWMU 2  
 Date: January 21, 1992.

History of Documented Releases: On July 24, 1988, an underground water pipe ruptured releasing approximately 170,000 gallons of water into the unit. Some wastes were observed floating in the 8 inches of water that covered the floor. Soil analysis conducted during closure detected contamination outside, immediately east of the building.

Observations: The unit was empty at the time of the VSI. While walking through the unit, RAI observed cracks in the floor. The unit is scheduled to have asbestos roofing removed, and later in 1992 will be torn down.

Photograph No.2  
 Orientation: South  
 Description: This is the interior of Building 48. Note the cracks in the floor.

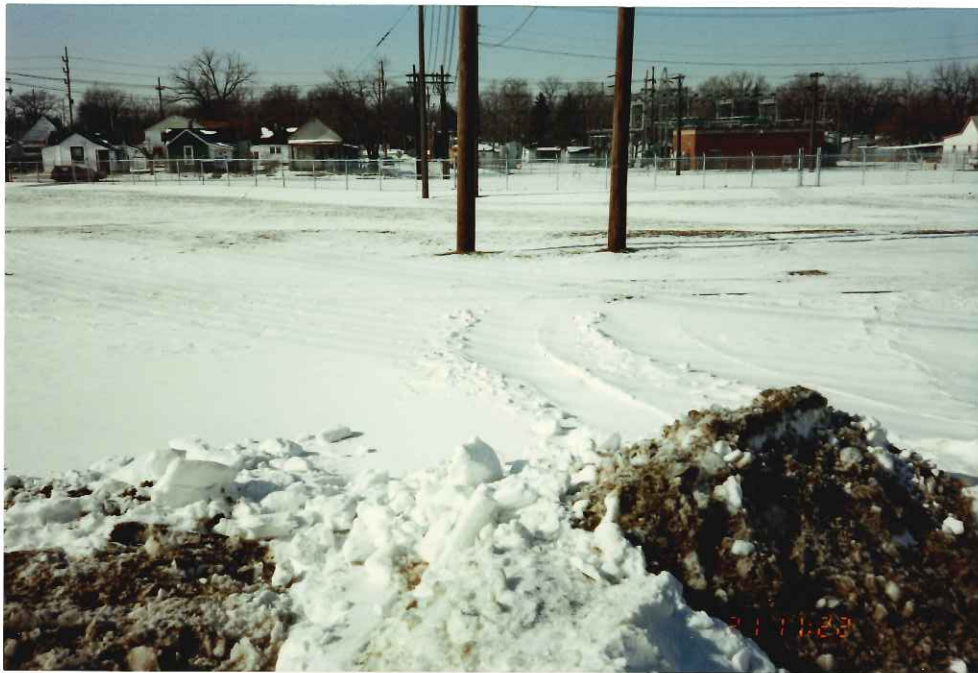
Location: SWMU 3

Observations: The area was covered with snow, so no evidence of a release was observed. The facility has submitted a site assessment plan to IDEM concerning remediation of the area.

Recommendations: The Ball facility should continue to follow the guidelines set forth in the Agreed Order concerning the remediation of the area.

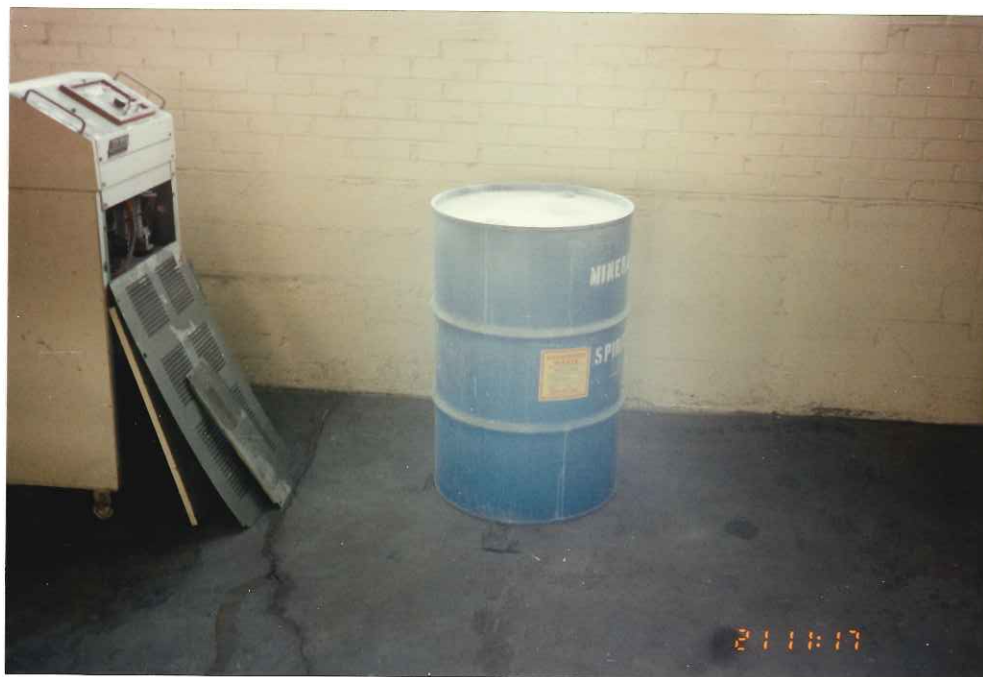
Location: SWMU 4

Observations: During the VSI, no evidence of a release was noted. All wastes appeared to be well-managed.

RAI recommends no further action for this unit.

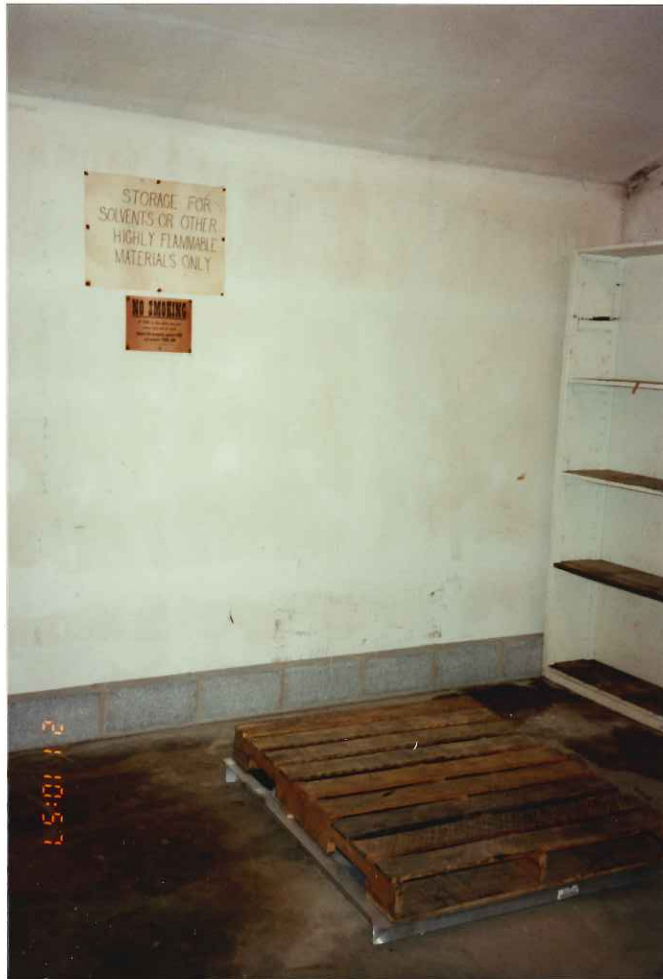
Location: SWMU 5

Unit Description: This 15-foot by 20-foot unit is located in Building 67 and is used to manage hazardous wastes for less than 90 days. The unit has prefabricated walls (plastic/stone), an 8-inch cinderblock berm on the interior, and is underlain by 4 to 6 inches of concrete (see Photograph No. 9).

Observations: The unit did not contain any wastes at the time of the VSI. The unit appeared well-managed and no cracks or floor drains were noted.

RAI recommends no further action for this unit.

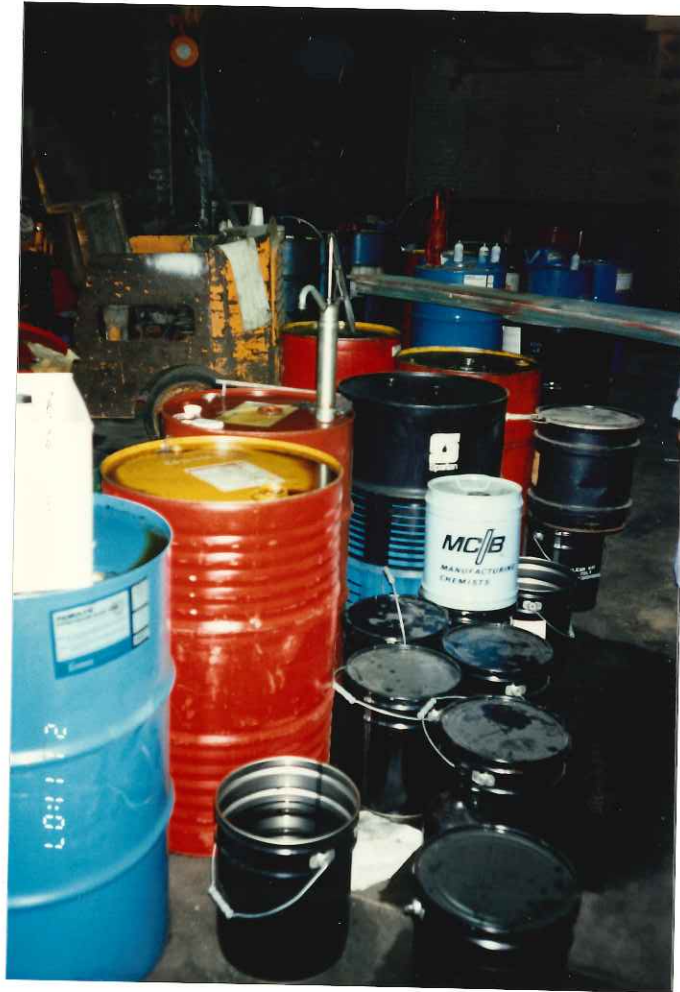
Location: SWMU 6

Date of Startup:	The unit began operations in 1987.
Date of Closure:	The unit is currently active.
Wastes Managed:	This unit manages waste hydraulic oil and motor oil.
Release Controls:	The unit has a concrete floor and no floor drains were noted.
History of Documented Releases:	There have been no documented releases from this unit. However, approximately 1 gallon of motor oil was observed on the floor.
Observations:	The unit contained numerous 5-gallon buckets and 55-gallon drums of waste oil. Oil was observed on the floor. It is possible that it was generated from the maintenance of facility vehicles.

This unit is used to manage nonhazardous waste hydraulic oil and motor oil. The area also is used to conduct maintenance of facility vehicles. The wastes are stored indoors, in 5-gallon buckets and 55-gallon drums and the building has a concrete floor. Other than the general oil and grease associated with a maintenance garage, no excess oil was observed on the floor. Potential for release to ground water, surface water, air, or on-site soils is low.

Recommendations: RAI recommends no further action for this unit.

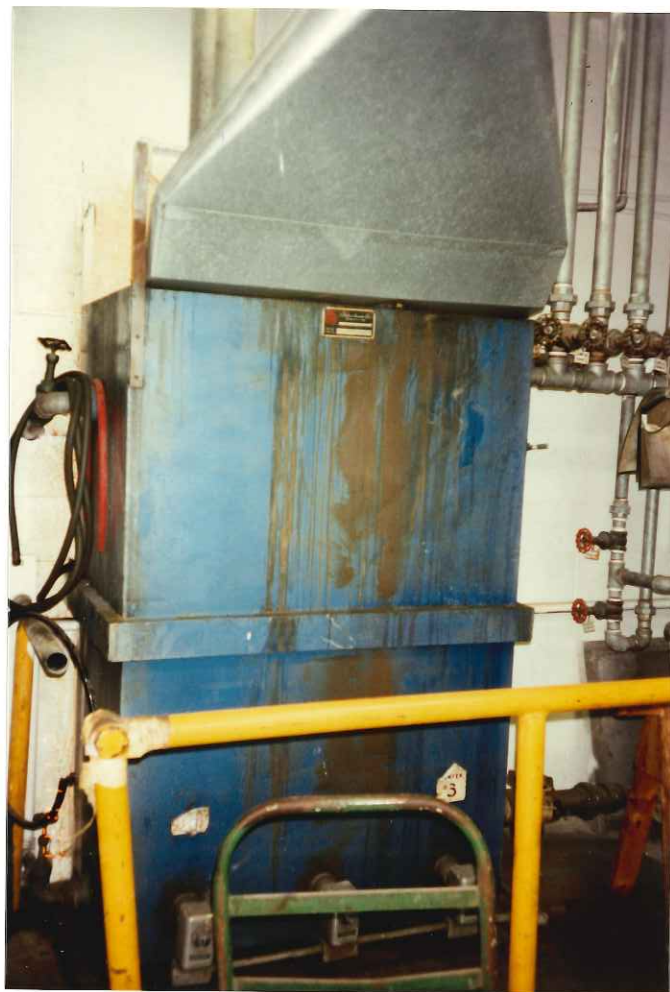
Location: SWMU 7

Observations: The steel tank appeared sound and no evidence of a release was observed.

Recommendations: RAI recommends no further action for this unit.
